REPORT OF INVESTIGATION

Surface Nonmetal Mine
(Phosphate)

Fatal Machinery Accident
September 27, 2005

Mosaic Phosphates Company
Fort Green Mine
Mulberry, Polk County, Florida
Mine I.D. No. 08-00768

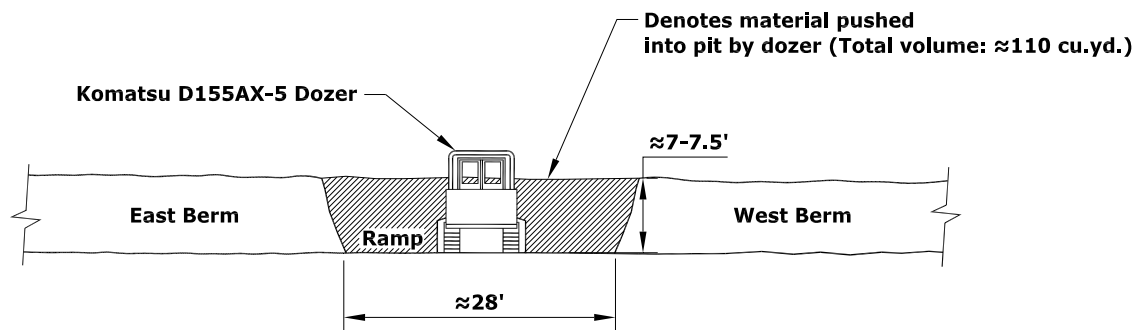
Figure 1

A berm, approximately 7.0 to 7.5 feet high, had been placed around the northern side of the pit. Based on laboratory test results provided by the company, the berm material was classified as fine sand with a trace amount of silt (Unified Soil Classification System). The dozer pushed about 110 cubic yards of the berm into the pit.

The ramp that the victim was constructing was located on the northern side of the pond. Investigators observed three sets of dozer tracks on the ramp. The ramp was 27.5 feet wide and was sloped down towards the water at a grade of approximately 5 percent. Prior to failure, the ramp was approximately 52 to 55 feet long and extended into the water approximately 10 to 12 feet. The remaining portion of the ramp was approximately 42 feet long and extended past the pond side of the berm approximately 3 feet. A vertical scarp, approximately 3.5 feet-high, was observed at the end of the ramp where it met the water.

Elevation View of Cut Through Berm Leading to Pit
Harsh Creek (HC-10) Cut (a.k.a. Old No. 16 Cut)
(Looking South)

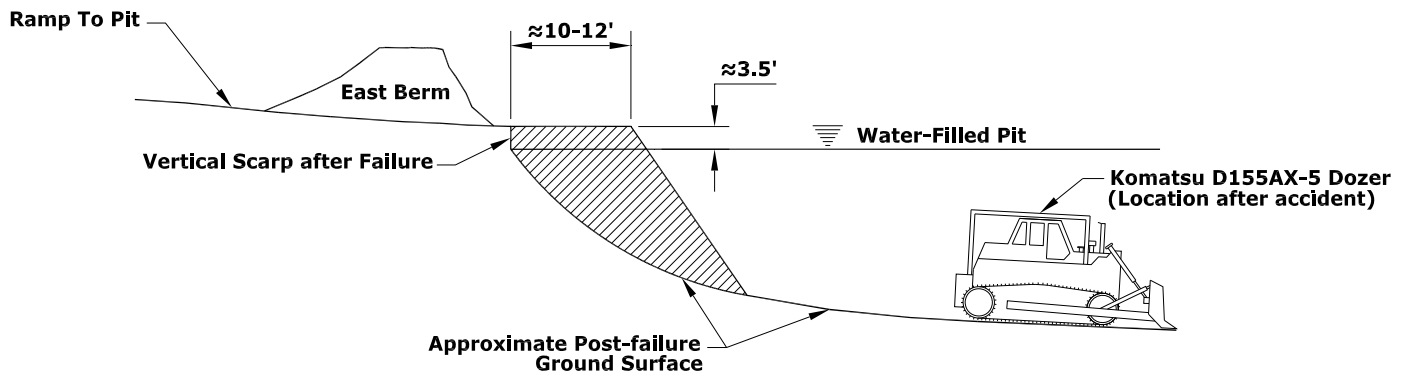
Figure 2

The center of the dozer, located approximately 45 feet from the edge of the scarp, was pointing downhill at an angle of 8.5° and there were no indications that it had rolled.

The accident occurred because the procedures used to construct the ramp were inadequate. The ramp was not constructed of materials capable of supporting the weight of the dozer. A risk analysis, to identify all potential hazards and establish procedures to safely complete this task, was not completed prior to building this ramp.

The configuration shown below (Pre-failure condition) is estimated based on measurements taken in the field during the investigation. All distances are approximate.

Diagram of Failure Scenario
Harsh Creek (HC-10) Cut (a.k.a. Old No. 16 Cut)
(Sectional View - Looking East)

Corrective Action: Management should develop and establish procedures to ensure that equipment operators and supervisors are trained to construct ramps capable of supporting the weight of the equipment operating on them. The procedures should require that miners visually inspect the ground conditions to identify hazards where ramps are constructed.

Corrective Action: Conduct a risk assessment to identify and eliminate or control any hazards. To safely construct the ramp, select equipment, such as an excavator, that can be operated a safe distance from the edge of the water.
